Design, Verification, and Forensic Correlation of Composite Yacht Structures

P H Miller, United States Naval Academy, USA

13. SUPPLEMENTARY NOTES Advanced Marine Materials Conference, Royal Institute of Naval Architects, London, UK, October 9-10, 2003					
14. ABSTRACT

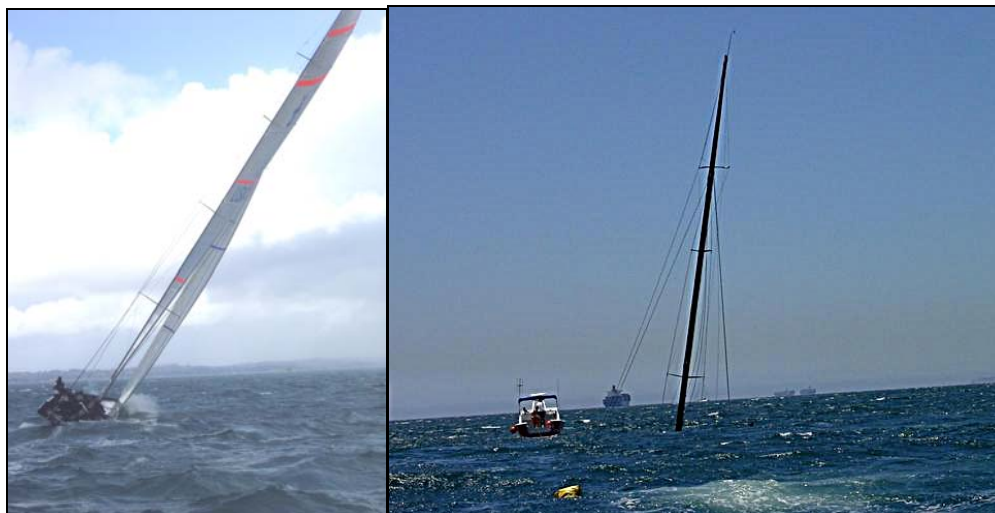
Figure 1: “Stars and Stripes” IACC USA-77

TDC's program included the design and construction of two (~25 m) vessels, five (~35 m) rigs and numerous keels, rudders, bulbs and winglets (see Figure 1). Working for about 16 months, TDC employed three part-time engineers to complement the principal naval architects, Reichel/Pugh Yacht Design (Harry Dunning - full time, Jim Pugh and John Reichel - part time) in the structural design of the hull, deck, internals, and appendages. Additionally the team developed the rigs and supported New England Boatworks, the builders.

Just prior to shipping the boats to New Zealand from Long Beach, California, USA 77 sank during practice (see Figure 1). Luckily it was in relatively shallow water and she was recovered in remarkably short time. While the cause was quickly determined, the bigger question was the extent of damage and the required scope of repairs.

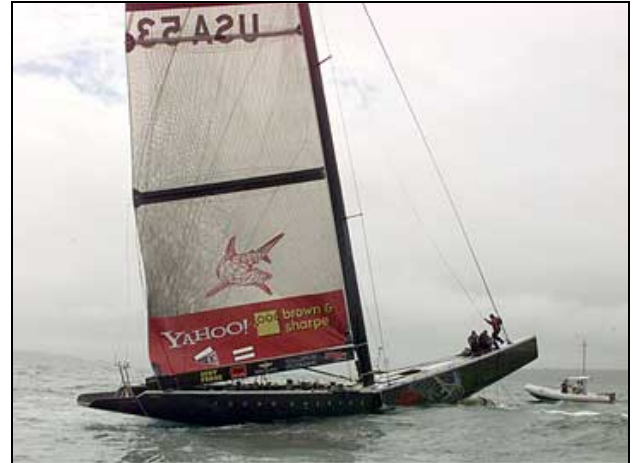
Figure 2: “Young America” suffering deck failure during the 2000 America’s Cup

IACC yachts are in many ways like a longbow that is being pulled back for firing. The arrow is the mast, the fore and back stays the bowstring, and the hull the longbow. Due to the large tension in the stays the mast experiences large compressive forces and the deck is in compression as the bow and stern bend upwards. The near loss of the IACC yacht “Young America” identified the sidedeck (Figure 2) as one of the critical components.

No published report identified the failure mode, however due to the compressive forces the failure was likely either compressive material yield or buckling, with delamination a possible contributing factor. In this area the partial side decks transition to a full-width foredeck near the area of maximum global bending moment. The IACC rules require the minimum thicknesses as: upper deck skin - 1.2 mm, lower deck skin - 0.9 mm, core - 14 mm. Additional uni plies are often added longitudinally to stiffen the hull. These can be added on either skin with the trade-off that adding them to the upper skin beneficially places them farther from the vessel’s neutral axis while negatively unbalancing the laminate.

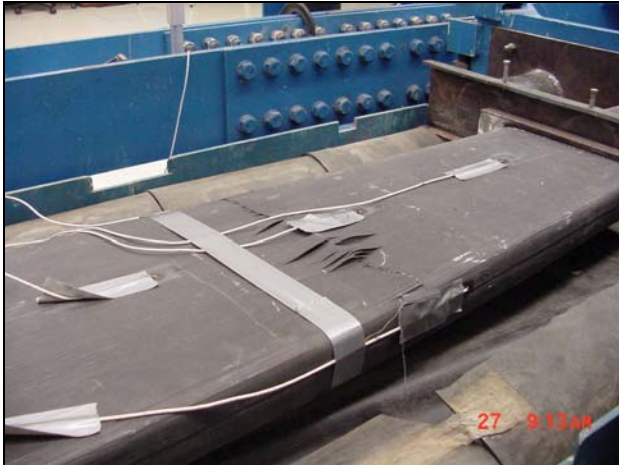
Figure 3: Deck panel test jig showing buckling failure

In addition to a full suite of coupon tests to determine the primary material properties, a full-scale test deck panel was built by the boatbuilder and tested at the U.S. Naval Academy’s Ship Structures Lab. Figure 3 shows the panel in the test jig, just after failure. As the test rig’s boundary conditions were different from the vessel’s due to the absence of the topsides, the local model was adapted to duplicate the test. Figure 4 shows the results. The squares show the FEA predictions and the diamond shows the test results. “0 Add’l Plies” means that all six plies were added to the lower skin. The best result was achieved with two of the six plies added to the upper skin, bringing the laminate closer to full balance.

The actual value observed in the test was 12% below that predicted by the FEA. Two likely reasons caused the discrepancy. First, the failure initiated about 45 mm from the predicted failure location. This was at the edge of a 3 mm indentation, 155 mm square caused by the vacuum bag breather pick up. Secondly, the end rotation boundary conditions were modelled as rigid. In reality the ends were potted in epoxy resin filled with 10% short glass fiber. COSMOS/M does not at present allow for elastic foundations in buckling analysis (although it does in other analyses). The next step would be to construct in the model artificially elastic foundations. Additional studies in this program included the effects of different close-out geometry with a cored closeout showing significantly higher buckling loads.

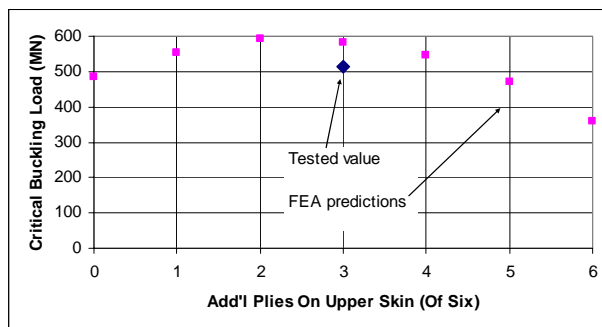
Figure 4: Ply distribution on buckling load

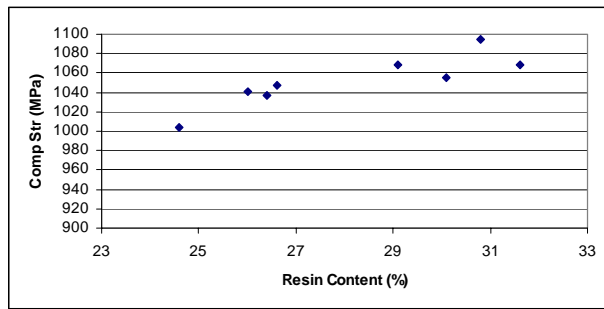
Figure 5: Compressive strength versus resin content

TDC and Southern Spars worked closely with the prepreg supplier, Newport Composites of Irvine, California to develop a product with the minimum resin content for mast construction while retaining toughness. Initial consideration looked at three resins, but preliminary tests showed one resin, while exhibiting slightly lower modulus, had higher compressive strength and toughness values. Figure 5 shows the resulting compressive strength versus resin content. Newport was comfortable with a 4% manufacturing variation, and the drop off near 28% led to a resin content specification of 30+/-2%. As the outer plies were more susceptible to resin bleed and abrasion, on later masts those plies were specified with 33% resin content.

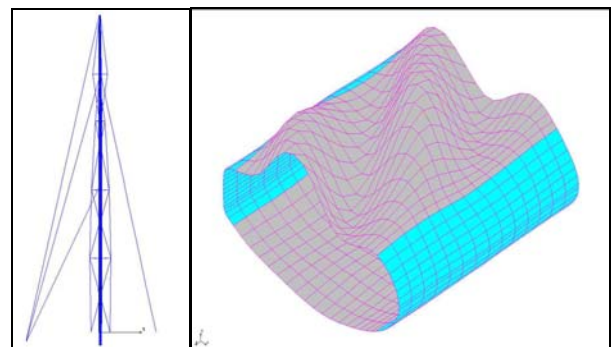
Figure 6: Global rig and local mast models

Figure 6 shows the global and a section of the local FEA mast models. The local model has two noticeable asymmetries in its results. These reflect the final calibration of the model to the test pieces and jig and the nature of the laminate. In addition to gravity, the boundary conditions were not exactly square, and the travel of the piston was not perfectly axial. The laminate was not perfectly symmetric and balanced due to an odd number of off-axis ply pairs.

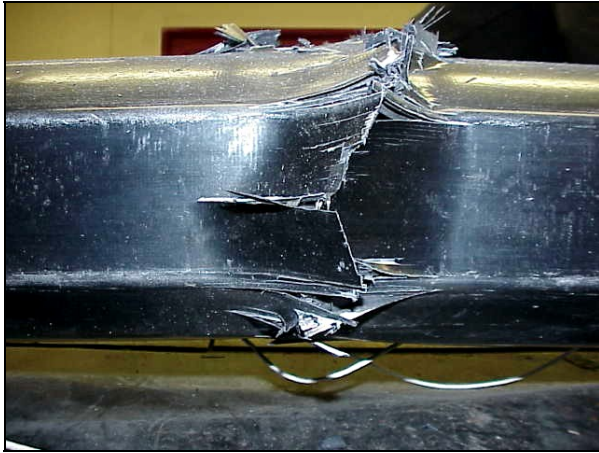
Figure 7: Failure of mast test section

The two tubes failed at 1.63 and 1.57 MN. Both failed in buckling in the same mode predicted by the FEA. Initial correlation between the model and tests had the tubes failing at 71% and 72% of the predicted values. Matching the actual tests' boundary conditions (loading varied as much as 7% from uniform) increased the correlation to 85%, and matching the tube as-builts brought the correlation to 89%. Figure 7 shows the failure of one tube. Failure initiated at the seam running longitudinally up the tube. The scarfed seam was not explicitly modelled however, but was included as a laminate thickness variation.

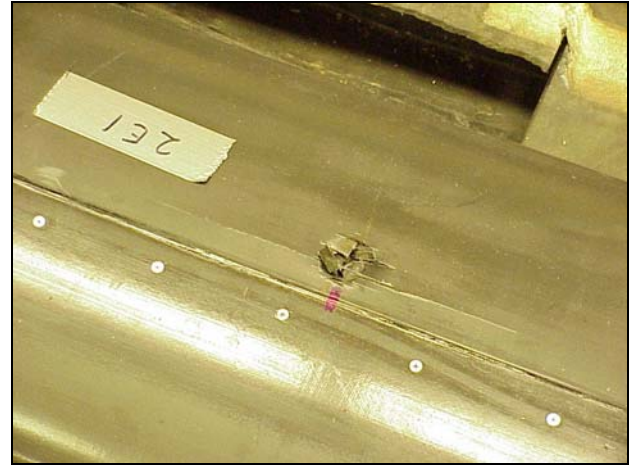
Figure 8: Puncture due to impact

TDC's rig team discussed the potential consequences with crew members, who enthusiastically supported the proposed tests. The crew provided pictures and samples of the gear and the potential likely operating conditions which would maximize the impact loads. These were translated into energy values and an impactor was designed to simulate the crewmember and their gear. Two 1.2 m tubes were built and tested. The tubes were loaded to 120% of the maximum design load and the impactor was dropped onto the thinnest portion of the laminate, adjacent to the longitudinal seam. The "most probable" design showed minor damage, while the "risky" design was punctured but did not otherwise fail. Figure 8 shows the damaged section. The longitudinal seam is clearly seen. Production models had wet laminated carbon cloth covering the fasteners and seam.

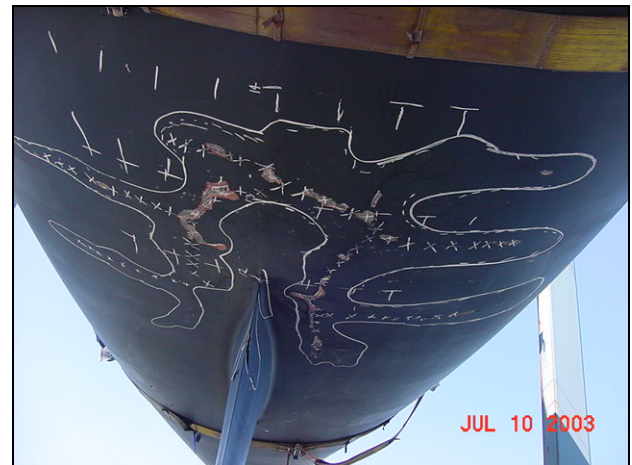
Figure 9: Damaged areas on “Cascadia”

Her structural design included cold-moulded cedar veneers, balsa core and carbon fabrics in a latent cure wet layup epoxy resin. Figure 9 is a picture of the damaged area and Figure 10 shows the corresponding FEA prediction. Again the correlation between the observed and predicted damage was excellent. In this case however the model did not predict damage in one area that did show damage. During excavation of the area it was found that the local reinforcement did not extend to the dimensions in the model. When the two were calibrated the model predicted damage.

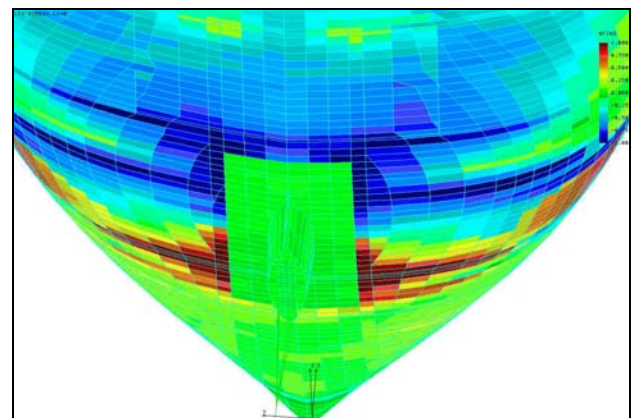
Figure 10: FEA predicted damaged areas on “Cascadia”

The model also predicted slight damage in the off-axis cedar plies in the topsides adjacent to the keel. This was not seen in the vessel however. Two possibilities exist for the discrepancy. First is the uncertainty in material properties. Shear tests for the laminated cedars were not performed, so conservative material properties based on short beam shear tests of free lumber were used. As wood often fails by fibre breakout, and the cold-moulding process restricts this somewhat, it may be that the actual material strengths were significantly higher than estimated. The second issue is with the aft boundary condition. It was modelled as a compliant foundation in tension, but how far the stern rises and the bow sinks during a grounding at the tip of a 3 m keel is difficult to model, yet can significantly effect the results.
